Findings Report

Safe Rooftop Solar Installation 2021

Project findings report - 1 March to 31 December 2021

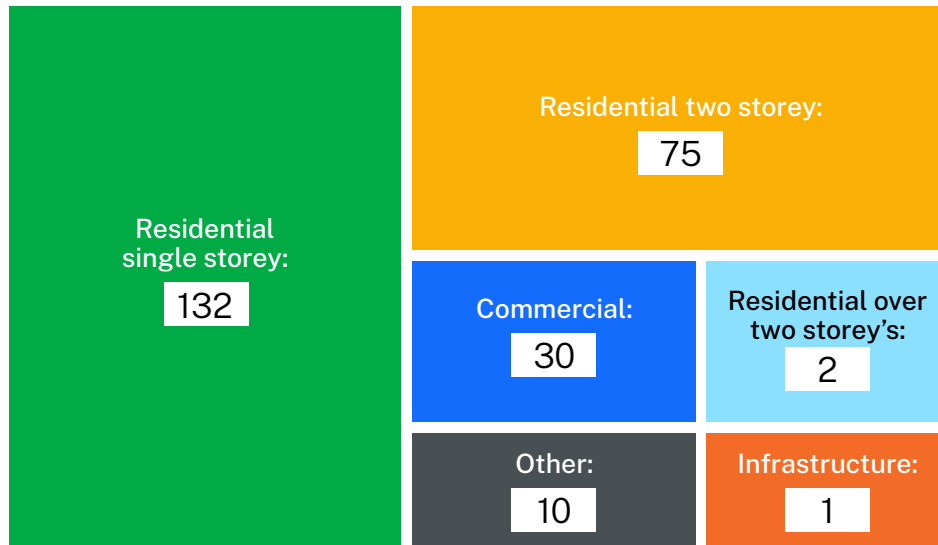
SafeWork NSW inspectors visited 286 sites where rooftop solar was being installed, with 84% of these sites being categorised as residential. 12% were commercial sites and 4% were 'other' (e.g., offices, sheds, workshops). One infrastructure site was also visited.

Table 1: Type of site visited as part of the Solar Installation project between 26/02/2021 -31/12/2021.

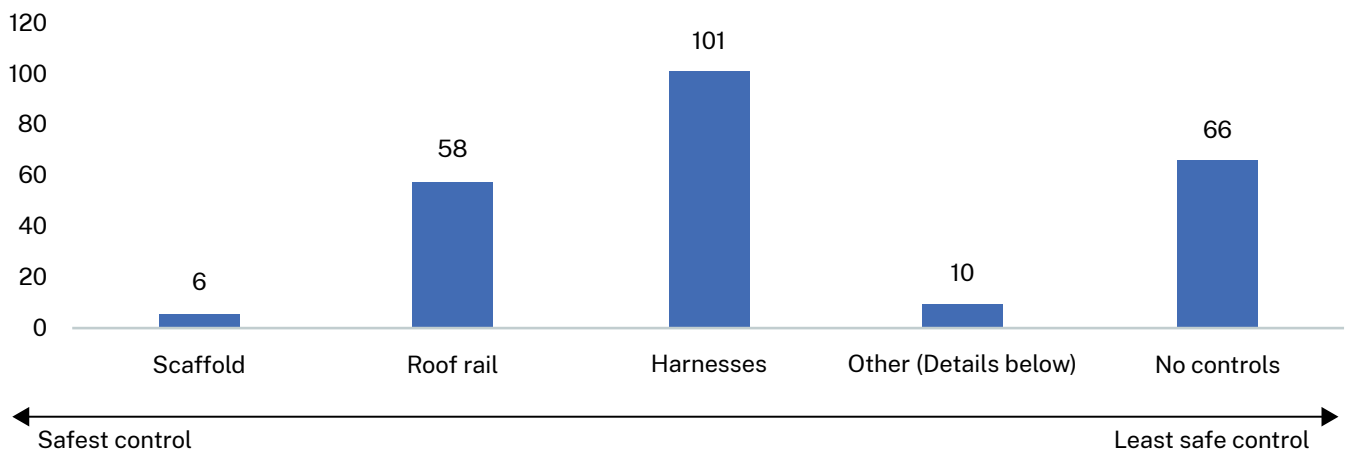
Type of fall protection implemented for roof work

The below table lists the fall protection that was in place at each site. Generally, scaffold and roof edge protection are a higher order (and safer) control when it comes to roof work. Harnesses should only be used as a last resort, if installing scaffold or roof rails is not possible due to the roof design or site.

4% of sites used scaffold, 24% used roof rails, 42% used harnesses and **27%** used no falls controls at all.

Table 2: Fall protection observed in the Solar Installation project between 26/02/2021 - 31/12/2021.

The “other” controls in the above table included bollard/flag system, no-go zone etc.

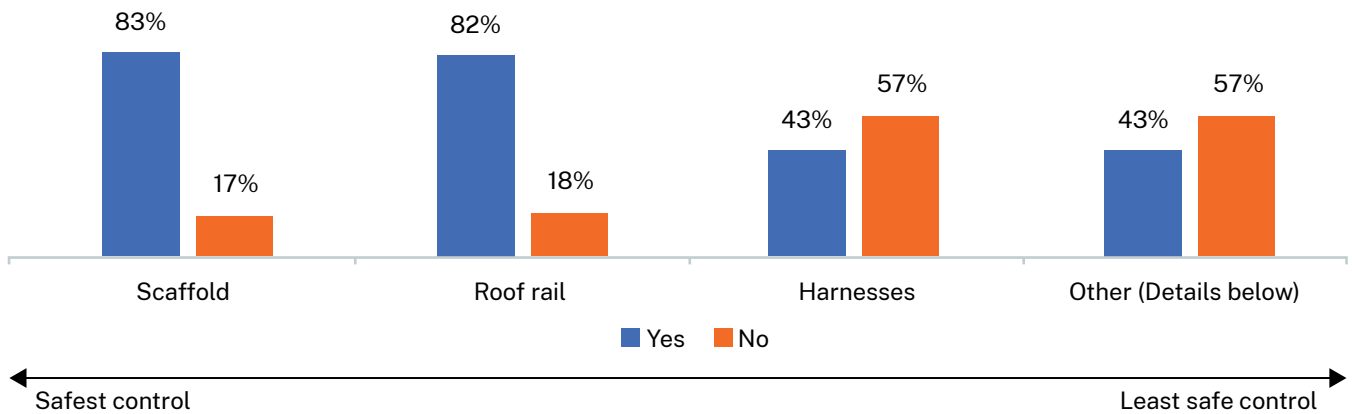
Were the controls in place being used safely?

47% of controls in place were not properly installed or implemented, and so workers were not protected.

The breakdown of the percentage of controls that were not installed or implemented safely is in the table below.

Table 3: Percentage of controls being used safely in the Solar Installation project between 26/02/2021 - 31/12/2021.

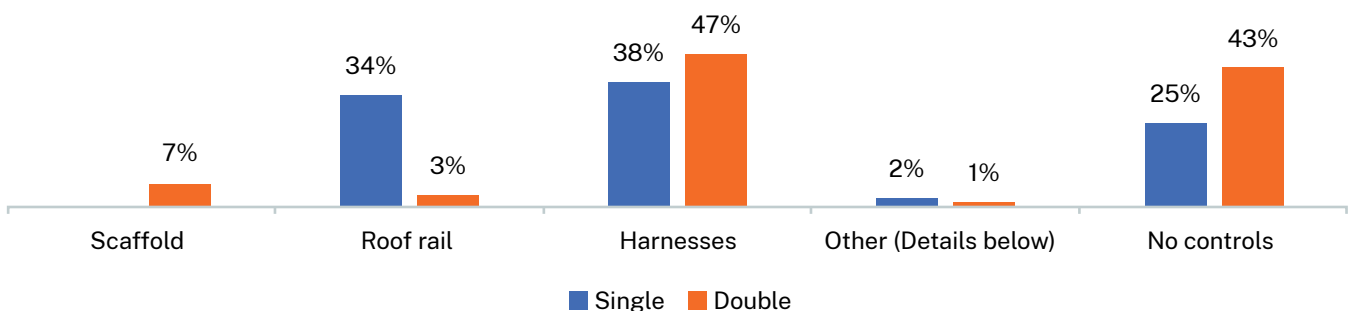
Single vs. Double Storey Falls Protection

We separated the type of fall protection in place for a single storey vs a double storey (plus) residential building. Whilst most serious and fatal falls are generally from less than 4 metres high, which is about a single storey, it is surprising that there was no fall protection in place for **25%** of single storey and **43%** of double storey.

Table 5: Single vs. Double Storey falls protection analysis for the Solar Installation project between 26/02/2021 - 31/12/2021.

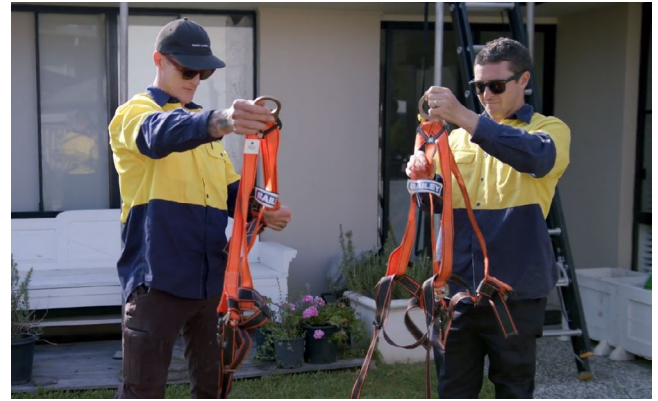
When we looked at the 43% of sites that were using harnesses as their highest order control, inspectors observed a high percentage of users who did not set up their system safely.

Additionally, inspectors observed that **50%** of harness users were not actually connected to anything.

These observations are in contradiction to the evidence collected by inspectors indicating that 83% of workers had received adequate training for the harness system used (or working at heights). The high percentage of unsafe set-up and use indicates that either industry training is inadequate, or that users are knowingly mis-using harnesses.

Harness Safety – inspector site observations	Yes	No
There is a plan/diagram that shows the system layout e.g., anchor placement etc	35%	65%
The system allows the worker to connect onto the system prior to exiting the ladder	49%	51%
The system prevents the worker from reaching a fall hazard when correctly adjusted	59%	41%
Proprietary anchors points are installed in accordance with the manufacturer’s instructions	68%	32%
Improvised anchors (rafters, beams) have been assessed by a competent person and appear structurally adequate to withstand load	61%	39%
Users are installing multiple anchors to cover the working area	45%	55%
The anchors, shock absorbing lanyards, harness, rope grab, static line are fall arrest rated	85%	15%
If using fall arrest, the installer has ensured enough clear space to prevent impact	44%	56%
The workers are wearing the harness correctly	77%	23%
If harness(es) is/are being used, the workers are connected to the system	50%	50%

Workers are adequately trained in the use of the fall restraint or fall arrest system	83%	17%

Table 6: Inspector safety observations related to harness set-up and use – percentage of sites with an answer of “yes” or “no” for each checklist question -in the Solar Installation project between 26/02/2021 -31/12/2021.

Additionally, the reliance of harnesses for fall protection continues to place workers lives at risk due to the high proportion of systems that are either set up incorrectly or not being used safely. Industry must continue to lift its standards in relation to using higher level fall protection, such as roof rails and scaffolds, opposed to harnesses.

SafeWork will continue to target safe solar rooftop installation as part of its Building and Construction Sector Work Health and Safety Plan, and recommends a review of current codes of practice and regulator guidance around safe work on roofs, including harness use.
