A3P Project: Stony Creek whole of system litter investigation & management prioritisation

Targeted Litter Surveys Summary Report

Technical Report No: 56

February 2022

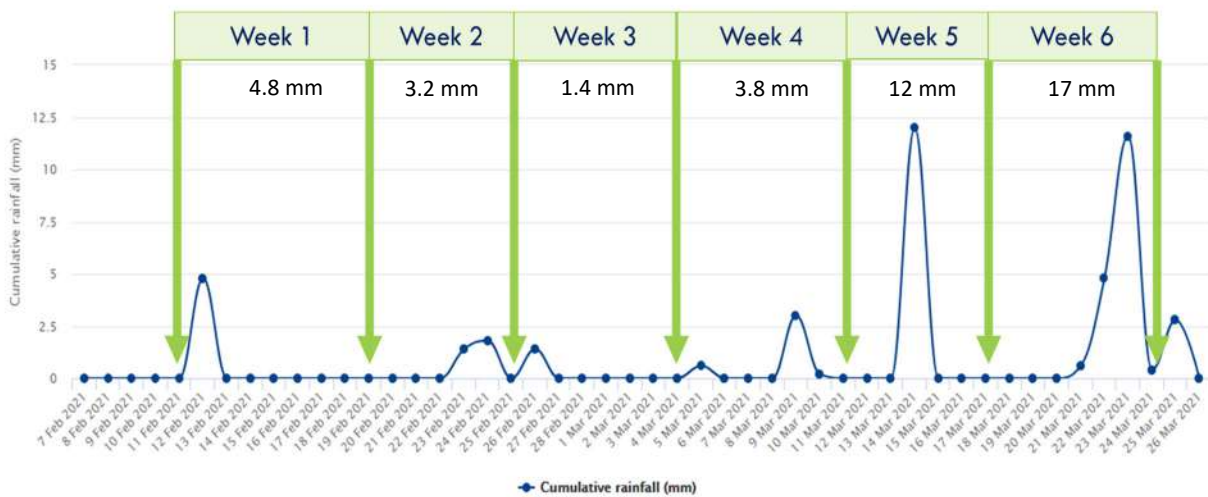
Figure 4: Cumulative (blue line) and total rainfall at Spotswood during storm drain surveys.

Rainfall during the stormwater drain survey period is shown in Figure 4. During weeks 1-4 small rainfall events occurred with total rainfall ranging 1.4-4.8 mm. During weeks 5 and 6 two significant storm events occurred resulting in total rainfall of 12 and 17 mm in each week respectively (Figure 4). This indicates that flow in Stony Creek during the first 4 weeks of sampling is representative of dry weather flows, while weeks 5 and 6 are representative of storm event flows (Figure 4).

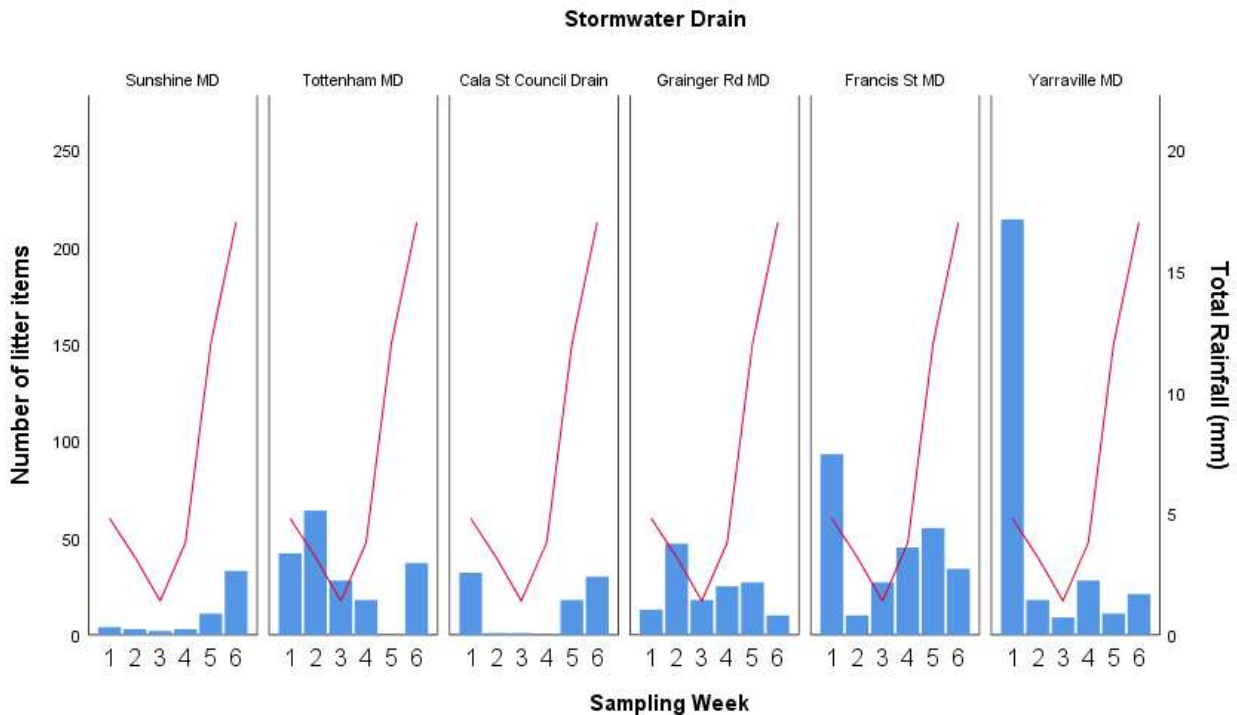
Figure 5: Weekly counts of litter items captured in nets deployed in stormwater drains discharging to Stony Creek (Blue bars) and weekly total rainfall measured at Spotswood (red line).

Thirty-six samples were collected from the six stormwater drains (6 samples per drain). Litter captured weekly from the six drains is shown in Figure 5, while total litter captured from each drain is shown in Figure 6 and Table 3. Litter loads over the sampling period varied for each drain (Figure 5). Highest litter loads were documented during Week 1 at Yarraville MD (214 items), whilst lowest litter loads were observed in Weeks 2-4 at the Cala St council drain (1 and 0 items respectively) and Week 5 in the Tottenham MD (0 items) (Figure 5). There was no relationship between litter loads and rainfall in the catchment (Pearson correlation $P > 0.05$; Figure 5).

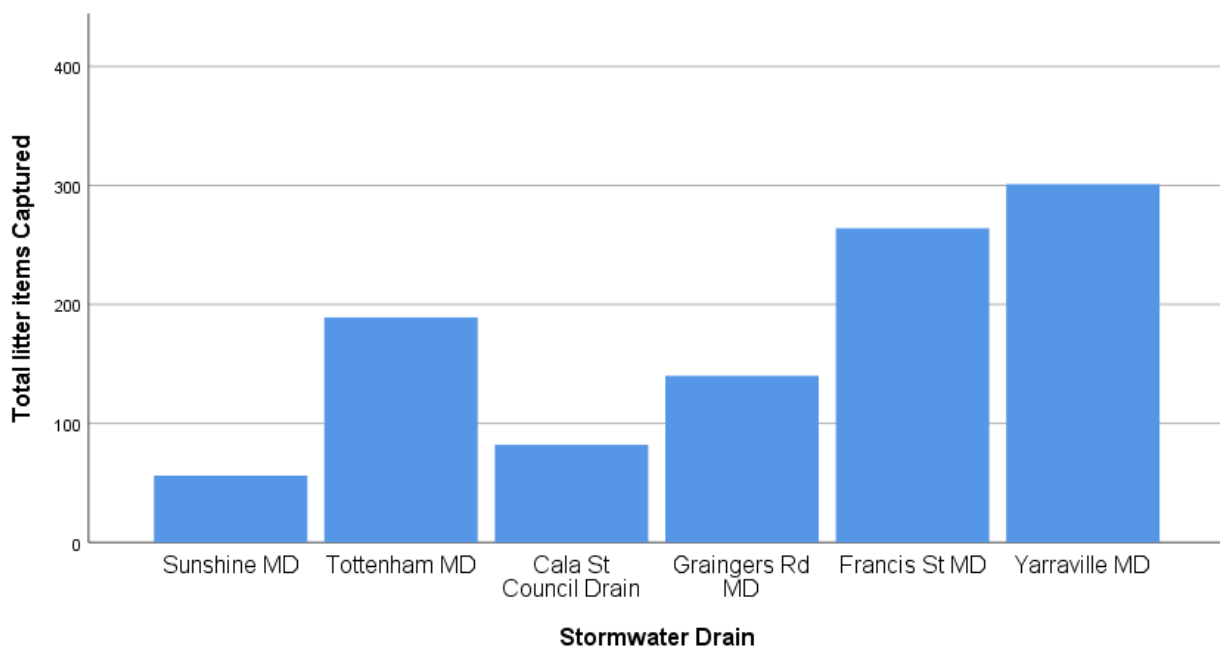
Figure 6: Total number of litter items captured in nets deployed over 6 weeks in stormwater drains discharging to Stony Creek.

Assessing overall litter captured during the study period, the highest litter loads (by number of items) were documented in Yarraville MD with 301 items, which was predominantly due to the large number of litter

items captured in Week 1 (Figure 6), with Week's 2-6 only contributing a total of 87 litter items. Francis St MD and Tottenham MD recorded the next highest litter loads with 263 and 189 litter items documented respectively, whilst lowest litter loads were observed in Sunshine with a total of 56 items documented (Figure 6, Table 3). The catchment area for each drain ranged from 0.96 km² (Cala St Council Drain) to 4.28 km² (Francis St MD), however there was no relationship between catchment size and the litter loads based on weight or number of litter items (Pearson Correlation $P > 0.05$; Table 3).

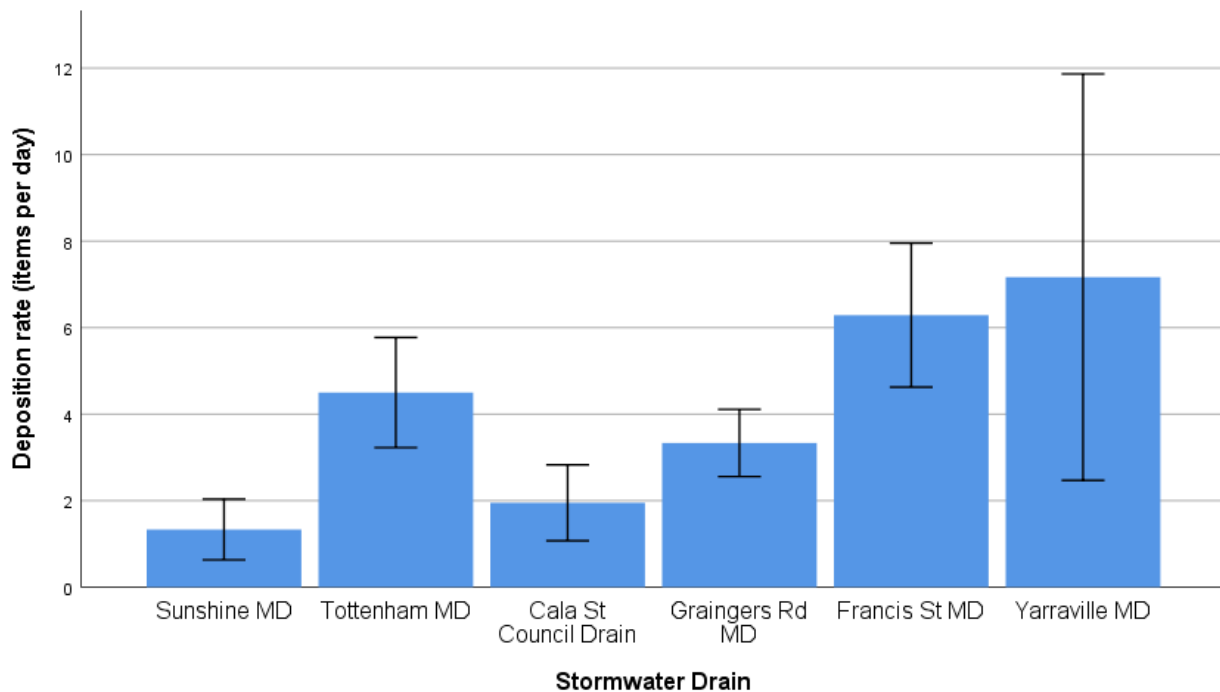
Figure 7: Mean deposition rates (items per day) for litter entering Stony Creek from stormwater drains. N=6

The monitoring design provided the opportunity to estimate litter deposition rates as litter was removed from nets during each site visit. Average rates of deposition (litter pieces per drain per day) were calculated for each site and are shown in Figure 7. Overall, the average litter deposition rate was 4.1 pieces of litter per drain per day. Deposition rates were lowest in drains discharging to Stony Creek in the most upstream reaches of the study area, generally below an average of 2 pieces of litter per day, except for Tottenham MD which averaged 4.5 litter items per day (Figure 7). Highest measured deposition rates were observed for the two drains that discharge in the most downstream reaches of the study area, Francis St MD and Yarraville MD with average rates of 6.3 and 7.2 items per day respectively (Figure 7). Of note is the high variability in deposition rates for the Yarraville MD, which is due to the large number of items captured during Week 1 sampling. With Week 1 rates removed the average deposition rate at this site is 2.5 items per day.

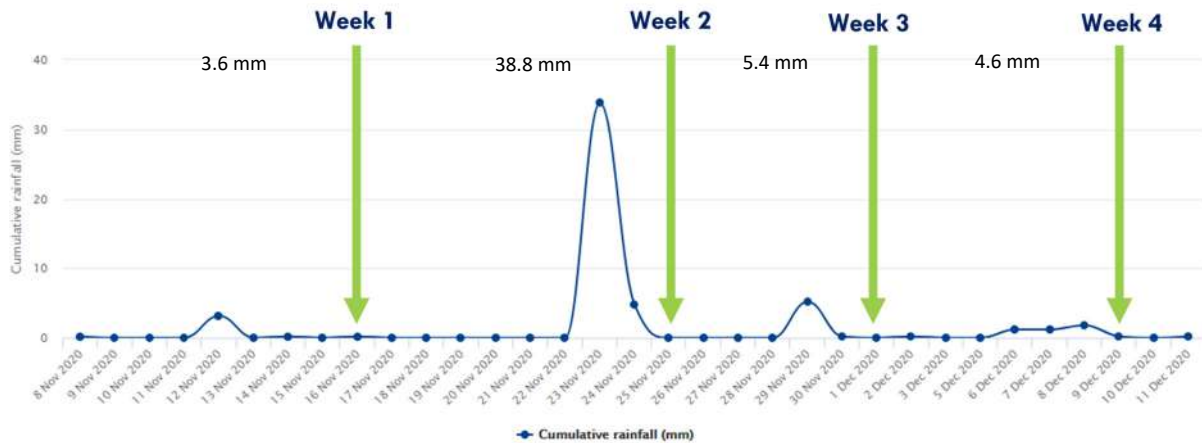
Figure 10: Cumulative and total rainfall at Spotswood during Bank Surveys.

Rainfall occurring during the bank survey period is shown in Figure 10. Generally, rainfall over the survey period was low (<6mm) except for week 2 where a significant rain event occurred late in the week (38.8 mm; Figure 10). This indicates that sampling during weeks 1, 3 and 4 is representative of dry weather flows, while sampling during week 2 is representative of storm event flows (Figure 10).

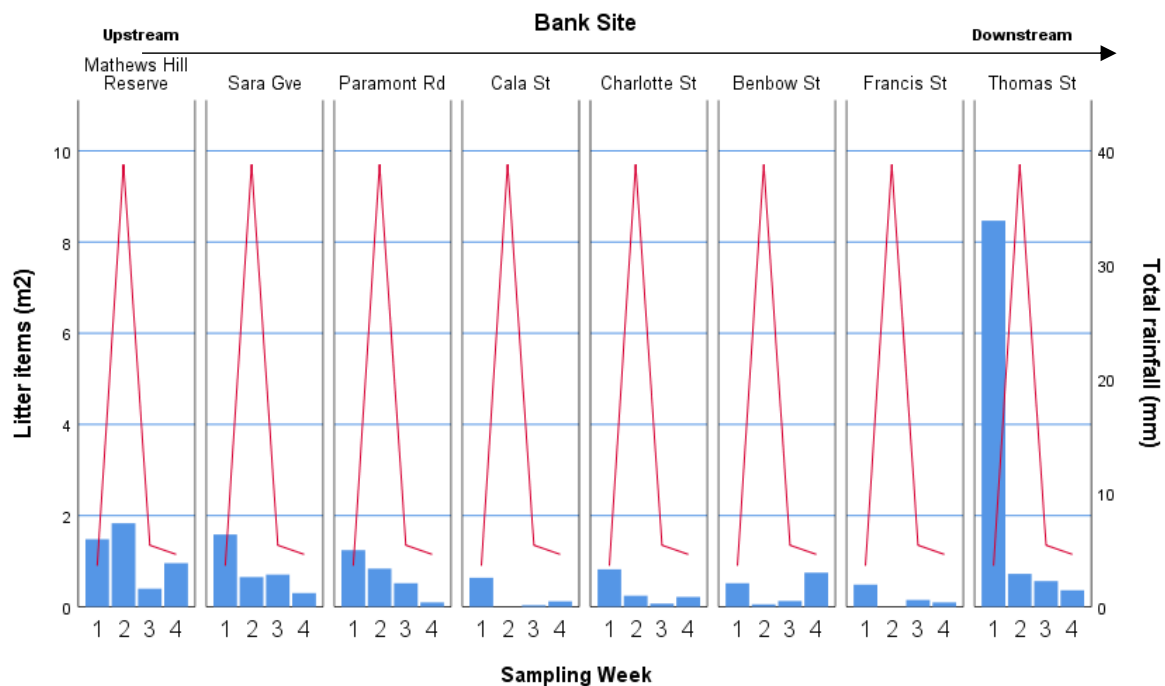
Figure 11: Weekly counts of litter items (m^2) collected from bank sites along Stony Creek (blue bars) and weekly total rainfall measured at Spotswood (red line). Note: Weeks 2-4 represent litter accumulated weekly, while week 1 represents litter present prior to the commencement of the surveys.

Litter captured weekly from the eight banks sites is shown in Figure 11, while total litter captured from each site is shown in Figure 12.

The amount of litter items collected showed no relationship with rainfall in the catchment (Pearson correlation $P > 0.05$). Rather, the highest amounts of litter were generally collected in Week 1 sampling across all sites, thereafter the number of litter items collected tended to decrease across the following sampling weeks (Figure 11). The exceptions were Mathews Hill Reserve and Benbow St, where highest amounts of litter were collected in Weeks 2 and 4 respectively (Figure 11).

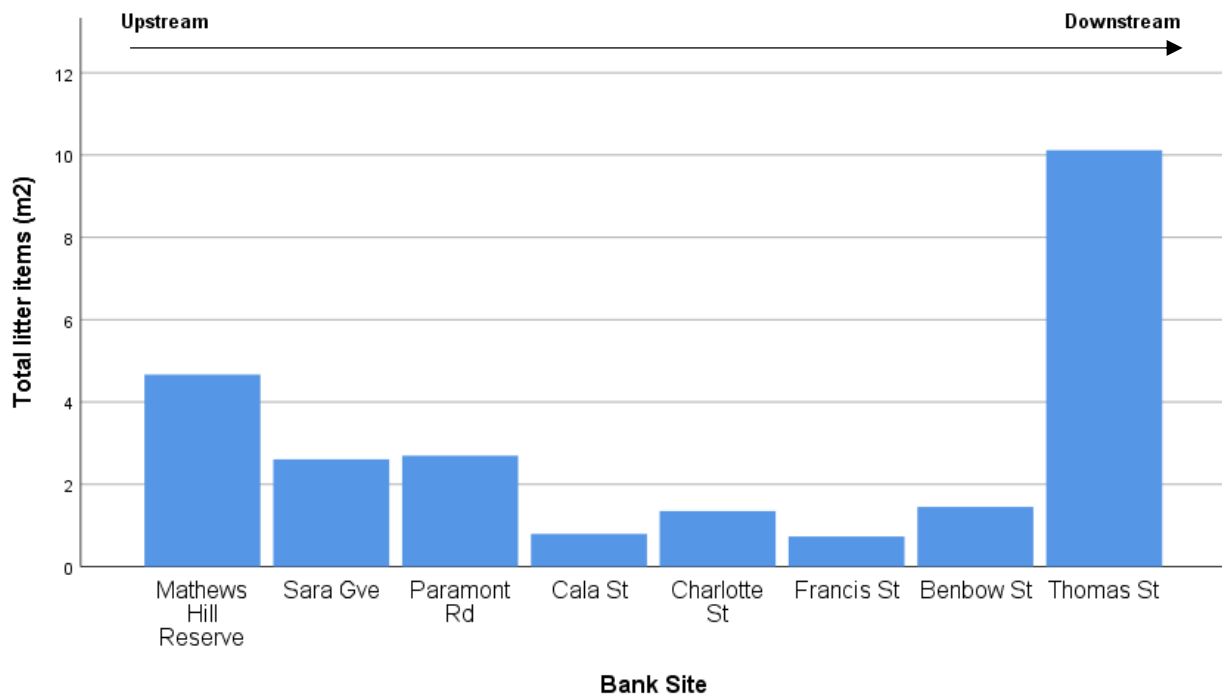
Figure 12: Total number of litter items (m^2) collected from bank sites along Stony Creek.

The most downstream bank site, Thomas St, had the highest litter levels (>10 items/ m^2), followed by the most upstream site, Mathews Hill Reserve (>4 items/ m^2), then Sara Grove and Paramount Road with just over 2.5 items/ m^2 . Lowest litter levels were observed at sites in the middle of the studied area (Cala St to Benbow St) with <1.5 items/ m^2 (Figure 12).

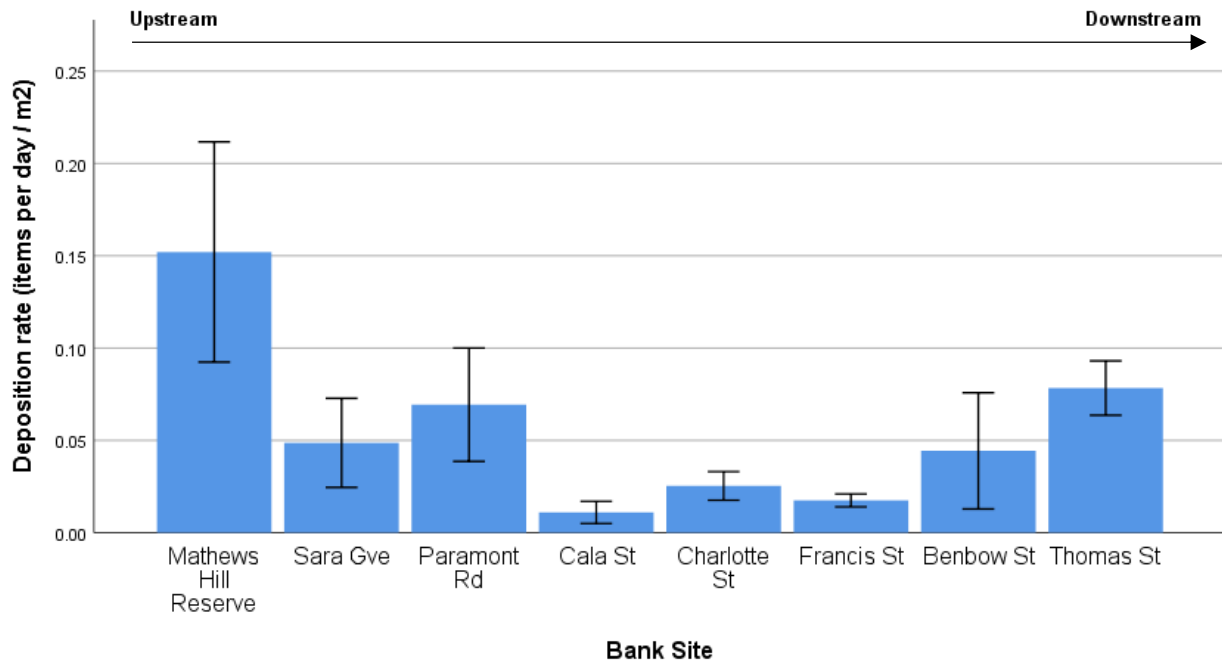
Figure 13: Mean deposition rates (items per day/m²) for litter on banks. N=3

The monitoring design provided the opportunity to estimate litter deposition rates as litter was removed from banks during each site visit. There was a total of 24 site visits (3 per site) that could be used to calculate deposition rates. A rate of deposition (pieces per day) was calculated for all sites and are shown in Figure 13. Overall, the average litter deposition rate was 0.06 pieces of litter per m^2 /day.

Deposition rates were lowest at bank sites in the middle of the study area, from Cala St to Francis St, where <0.03 litter items were deposited per day / m^2 (Figure 13). Highest measured deposition rates were observed at Mathews Hill Reserve, followed by Thomas St and Paramount Rd, with average rates of 0.15, 0.08 and 0.07 items per day / m^2 respectively (Figure 13). At Sara Grove and Benbow St, average litter deposition rates were 0.04 items per day / m^2 (Figure 13).

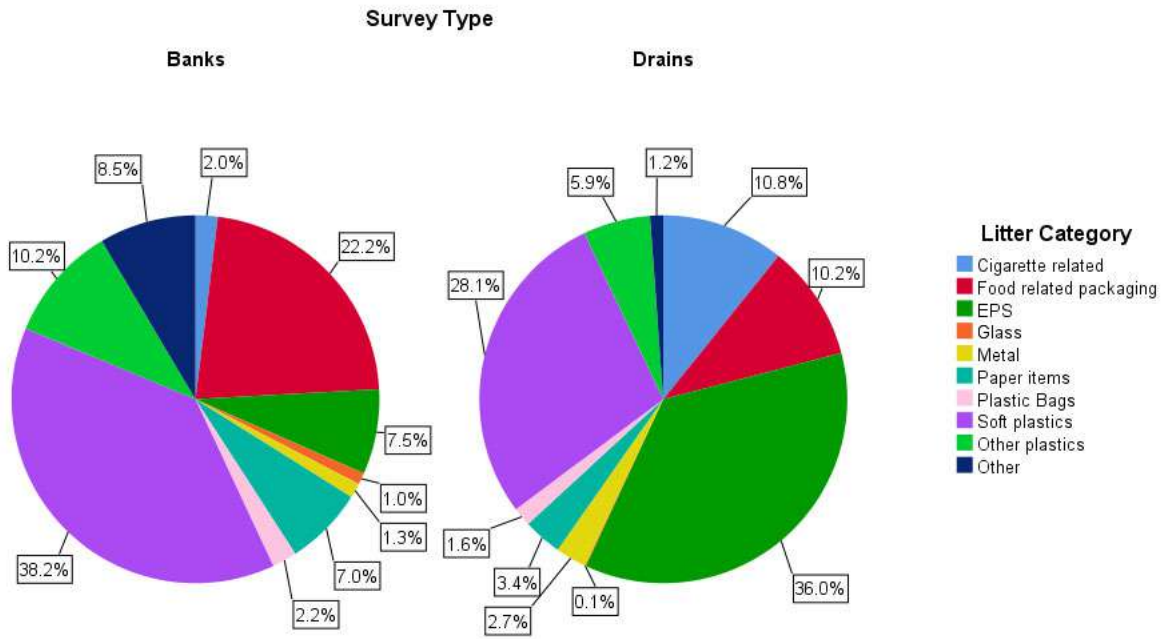
Figure 15: Contributions of different litter types in bank and stormwater drain surveys. Drains N = 1031; Banks N = 1899.

The breakdown of litter (by number of items) collected during the bank surveys and stormwater drain sampling events is shown in Figure 15. Soft plastics, followed by food related packaging and other plastics, which was mostly hard plastic pieces, were the dominant litter types contributing to loads on Stony Creek banks, while EPS, soft plastics, cigarette related items and food related packaging dominated the litter loads from stormwater drains (Figure 15). Heavier items such as glass and metal contributed the lowest to litter loads for both banks and stormwater drains. Remaining litter categories, which includes paper items, plastic bags and other mixed materials contributed between 2 to 9% and 1-3% for bank and stormwater drains, respectively (Figure 15).

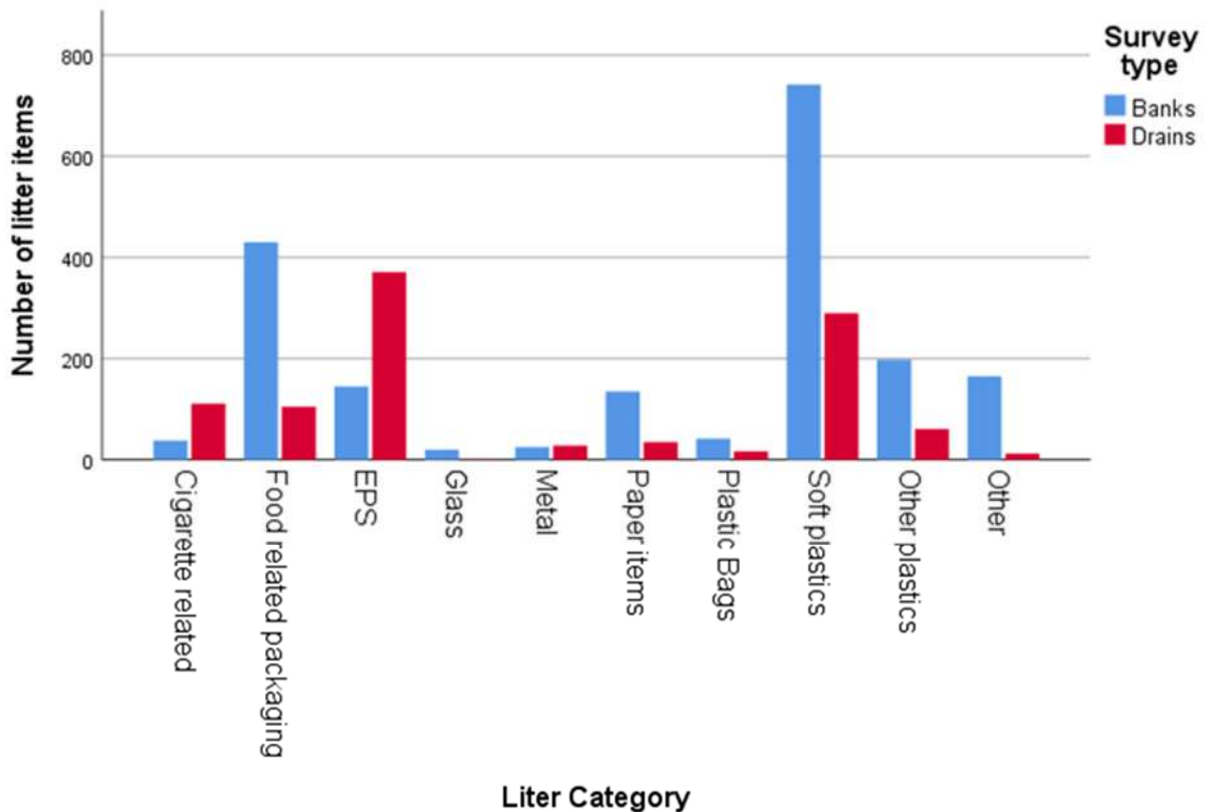
Figure 16: Number of litter items collected from banks and storm drains in the different litter categories. Drains N = 1031; Banks N = 1899.

Generally, a greater number of litter items were collected from creek banks, compared to through the stormwater drains, for each of the litter categories, with total litter collected from banks being nearly double that collected from the stormwater drains (1899 items for banks, 1031 items in storm drains; Figure 16). The exceptions were the categories of EPS and cigarette related material which were collected in much greater quantities from stormwater drains. Additional characterization data is available in Appendix A.

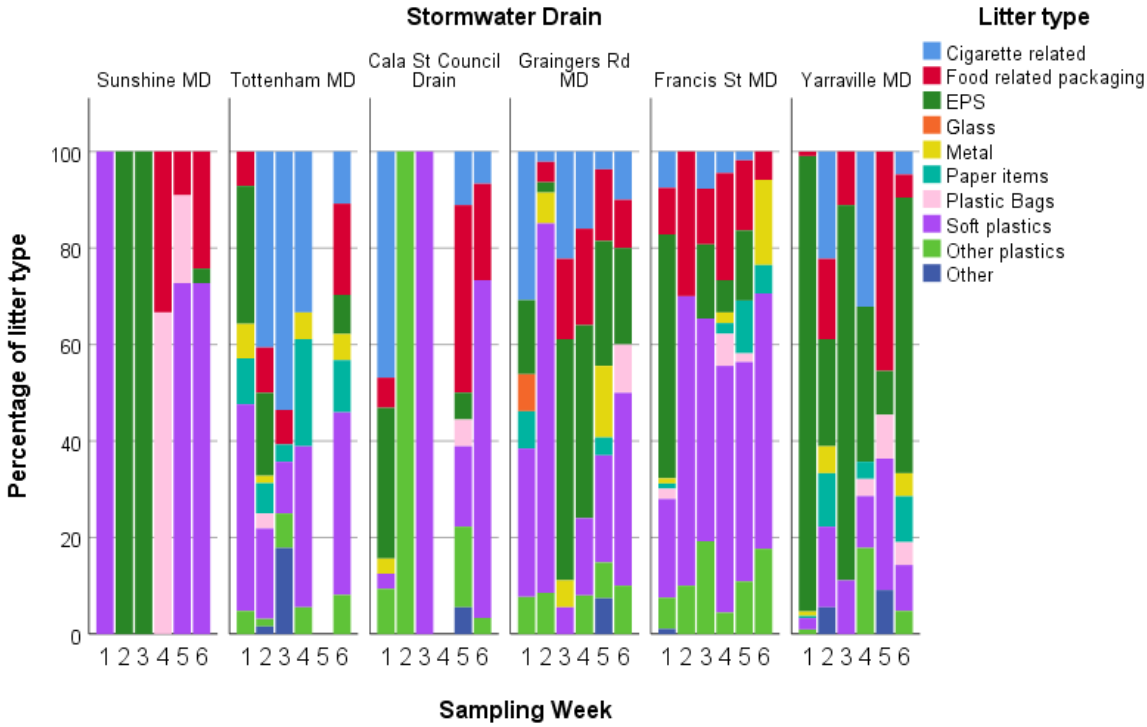
Figure 19: Composition of litter captured from stormwater drains according to sampling week.

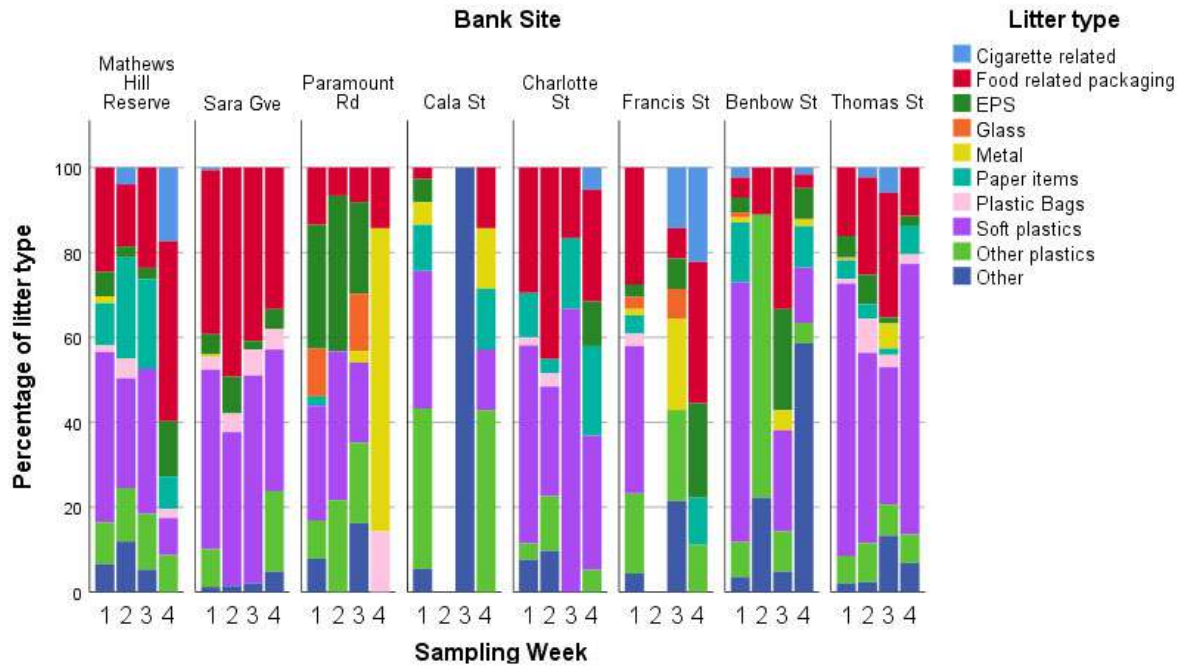
Figure 20: Composition of litter captured during bank surveys according to sampling week.
